# Manhole Inspection Summary

Manhole # S55E\_\_018MH

Insp Date: 7/21/08 1:25 PM

**Location** Address: **rear 3800 e lombard st**

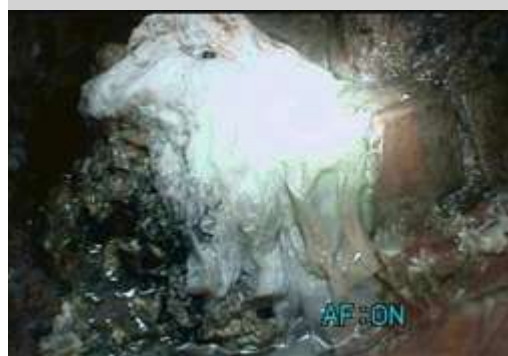
misc

bench debris

channel debris

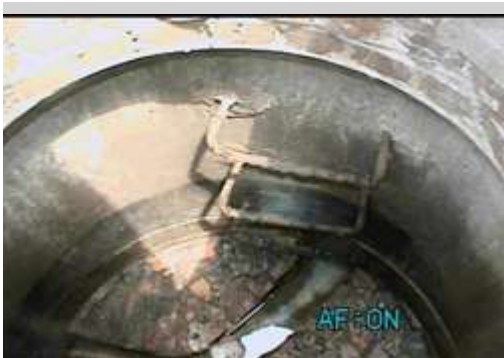
Defect 2

Count: **3** Missing: **0** ☒ **Corroded**

corroded steps

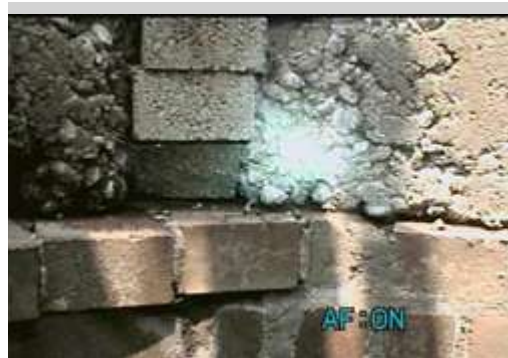
Defect 1

Condition: ☐ Sound ☐ Cracked ☐ Root Intrusion ☒ **Loose Brick** ☒ **Deteriorated**

chimney loose bricks deteriorated frame adj

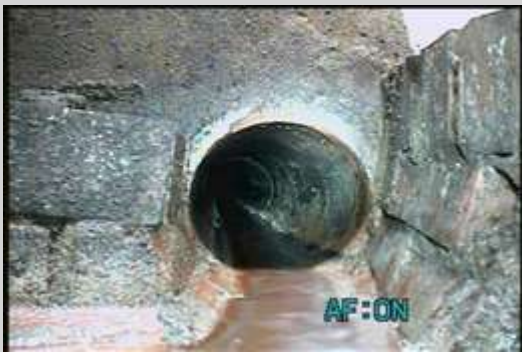
12 O'Clock Outflow

8 in. Circular Gravity Sewer  
Pipe Out @ 12 O'Clock

Invert Depth: 7.55 (ft.) Flow Characteristics: Fast

Infiltration: None Pipe Seal Cond: Unknown

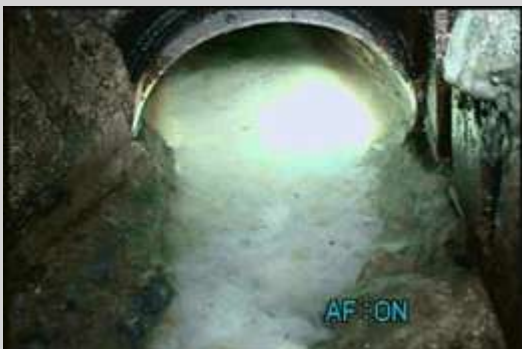
3 O'Clock Inflow

8 in. Circular Gravity Sewer  
Pipe In @ 3 O'Clock

Invert Depth: 7.45 (ft.) Flow Characteristics: Slow

Infiltration: None Pipe Seal Cond: Unknown

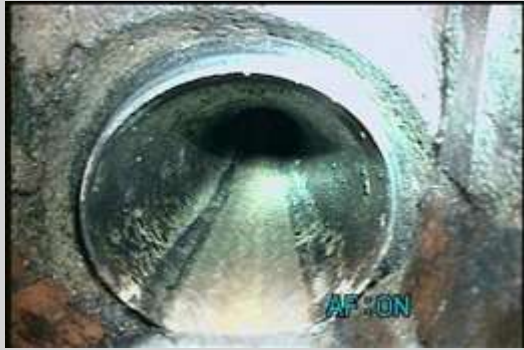
6 O'Clock Inflow

8 in. Circular Gravity Sewer

Pipe In @ 6 O'Clock

Invert Depth: **7.43** (ft.) Flow Characteristics: **Fast**

Infiltration: **None**

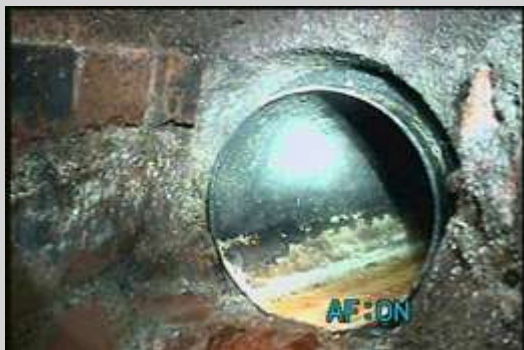
9 O'Clock Inflow

Pipe In @ 9 O'Clock

couldnt get better picture pipe on angle

Invert Depth: **7.37** (ft.) Flow Characteristics: **Fast**

Infiltration: **None**
